Crooked Creek Design/Build Report

Kosciusko County, Indiana

December 10, 2003

CROOKED CREEK DESIGN/BUILD REPORT EXECUTIVE SUMMARY

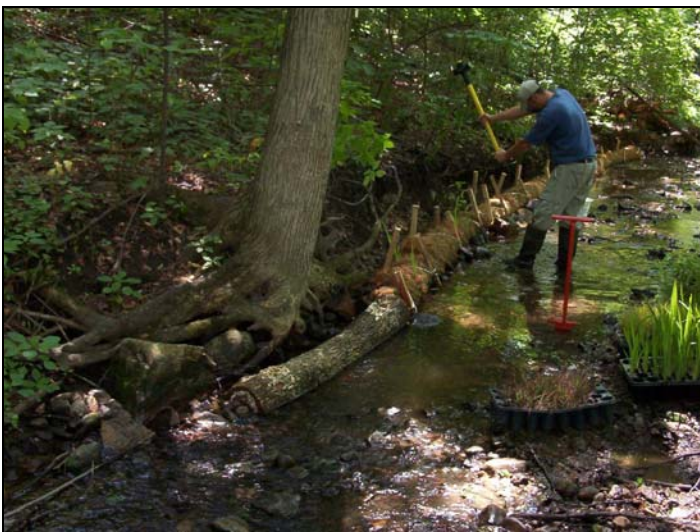
Figure 2. Coir log installation.

Approximately 230 feet of biolog was installed along Crooked Creek. Coir logs (Biologs) were installed along eroding streambanks where the distance from the top of the bank to the stream bottom was less than two feet. Coir logs were placed to follow the existing streambank's contour in most places (Figure 2). In areas where erosion had created scour holes in the streambank, coir logs were contoured to approximately follow the streambank prior to scour hole creation. After placement, coir logs were secured with oak stakes and nylon rope. Coir logs were then planted with a variety of native plant plugs. Once fully grown, the native plant roots will further stabilize the streambank after the coir logs have deteriorated. A planting list can be found in Appendix C.

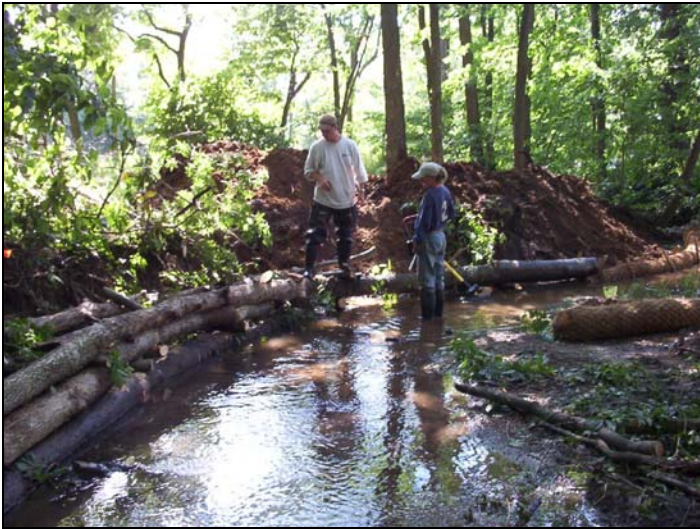
Figure 3. Cribwall installation.

Approximately 1,090 feet of cribwall was installed along Crooked Creek and its tributary. Logs used for cribwall construction were obtained from trees on-site. Trees were either obtained from windfalls or from areas that were thinned to promote greater understory growth. Logs were cut to the appropriate length and placed by hand or with the assistance of a mini-excavator. Log diameter ranged from approximately 12 to 24 inches for base logs (logs located on face of the cribwall) and 4 to 6 inches for cross-logs (logs that tie the base logs to the streambank). Base logs were first installed then a series of cross logs were placed along its length. A series of pilot holes were created in each log with a power auger equipped with a drill bit. Three-foot rebar stakes were then driven through the log into the streambank or streambed with a sledgehammer. The number of rebar stakes used in each log depended on the log's length. The cribwall was built to the appropriate height by repeating this procedure (Figure 3). The void created behind the cribwall was filled with fieldstone by a skidster within several inches from the top base log. Soil was then placed over the rock and seeded with a native bank stabilization seed mix (Appendix C). Straw erosion control blankets were then stapled over the seeding area and placed between the gaps in the cribwall. Design details for cribwalls can be found in Appendix A.

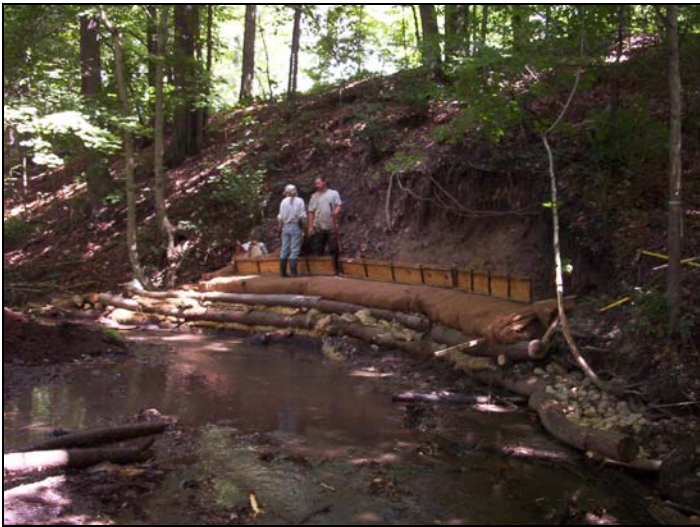
Figure 4. Installation of soil encapsulated lift on top of cribwall.

A total of 50 feet of soil-encapsulated lifts were installed on top of a cribwall along a high, eroded bluff. Soil encapsulated lifts were placed on top of the cribwall due to the mini-excavators inability to safely place logs at the height required to obtain streambank stability. Lifts were constructed by placing a 50-foot length of coconut erosion control blanket over a form then filling the area behind the form with soil. The lift was seeded with a bank stabilization seed mix, encapsulated with the blanket, and then stapled. The forms were removed and then placed on top of the lift to begin construction of the next lift (Figure 4). A total of three lifts were constructed in this manner. The total height for all three lifts and the cribwall was approximately five feet. Design details for soil encapsulated lifts can be found in Appendix A.

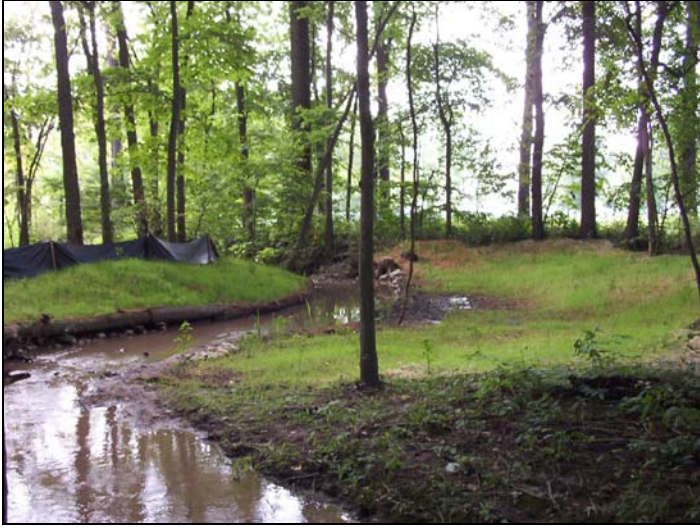
Figure 5. Native plantings along disturbed banks.

A custom seed mix was applied over areas disturbed by construction equipment, on soil-encapsulated lifts, and on top of cribwalls (Figure 5). Coir logs were planted with a variety of native plant plugs. A complete planting list can be found in Appendix C.
